A true tall tale about the Hancock Tower

Builders faced bigger crisis than falling windows

By Robert Campbell
GLOBE CORRESPONDENT

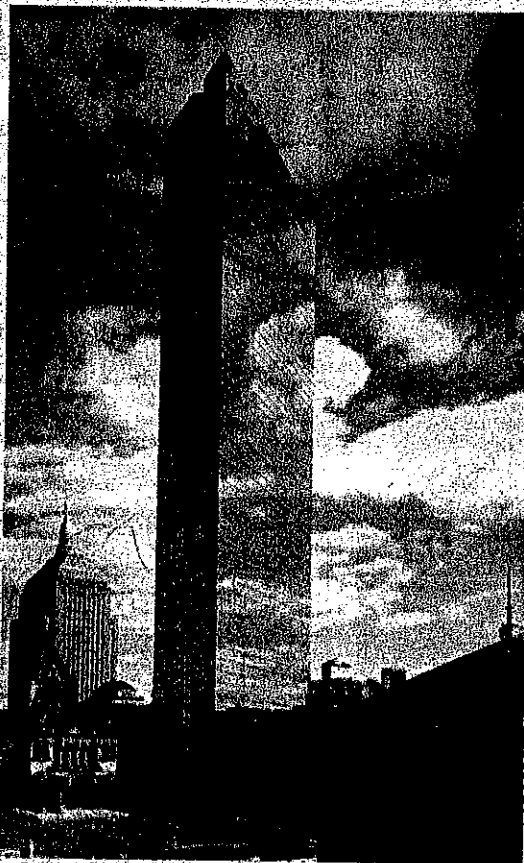
Scores of windows fell from the John Hancock Tower while it was under construction, leading to the replacement of all 10,344 windows with sheets of tempered glass. Plywood was used in the interim (left).

After all this technological excitement, the solution to the mystery of the falling glass comes almost as an anticlimax. Samples of the Hancock window panels were being exhaustively tested in a wind tunnel in Ontario. They were subjected to vibration and oscillation until they failed. Eventually it was found that the whole problem was right there in the window unit itself.

Each panel was a sandwich: two layers of glass with an air space between, all held in a metal frame. To cut the glare and heat of the sun, a coat of reflective chromium was placed on the inside surface of the outside pane of glass. (This layer of chrome was what gave the building its mirror effect.) The window frame was bonded to the chrome with a lead solder. During the testing, it was noticed that when a window failed, the failure began when a tiny J-shaped crack appeared at the edge of an outside pane of glass. What was happening was this: The lead solder was bonding too well with the chrome — so well, so rigidly, that the joint couldn't absorb any movement. But window glass always moves. It expands and contracts with changes in temperature, and it vibrates with the wind. So the solder would fatigue and crack. The crack would telegraph through to the glass, and the cycle of failure would begin.

spicuous buildings. All 10,344 of the Hancock's double-pane windows were replaced with single sheets of tempered glass. The window maker paid the cost, which was \$7 million. Part of the deal was that everyone agreed to keep the secret.
